**PRELIMINARY ASSESSMENT/
VISUAL SITE INSPECTION**

**CABLEC CONTINENTAL CABLES COMPANY
MARION, INDIANA
IND 062 803 697**

FINAL REPORT

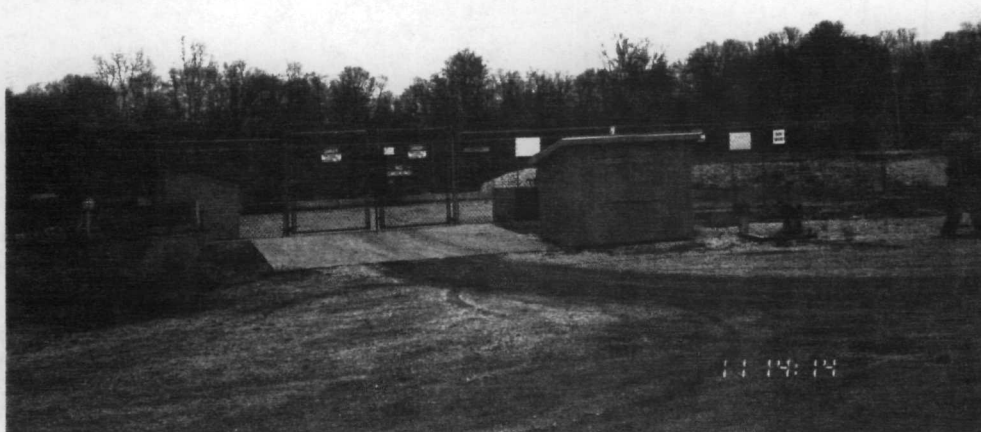
Photograph No. 1

Observations: The unit (at the time of the VSI) contained 55-gallon drums of spent toluene and waste lead filters (See Photographs No. 1, 2, and 3). The pad contained many cracks, some of which appeared to have been sealed. The area in the southwest quadrant of the pad appeared

Description: Fenced in area (constructed of a curbed concrete pad) with a double gate entrance.

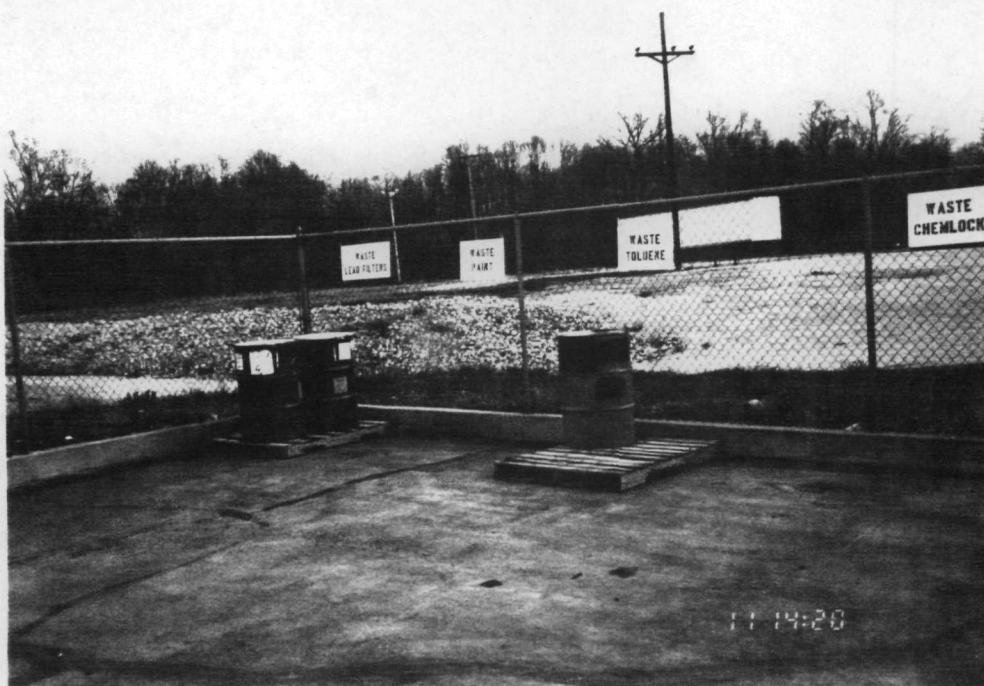
Photograph No. 2

Description: Stacked waste drums organized by signs showing types of wastes.

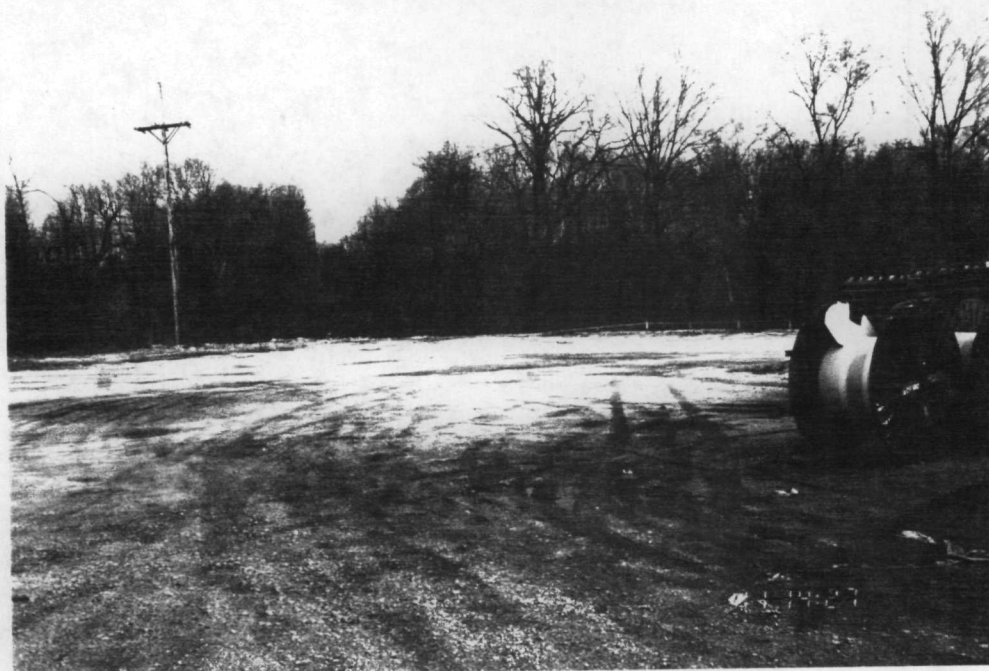
Photograph No. 6

Observations: At the time of inspection, there were no drums in this storage area (See Photograph No. 6).

Description: Former hazardous waste storage area.

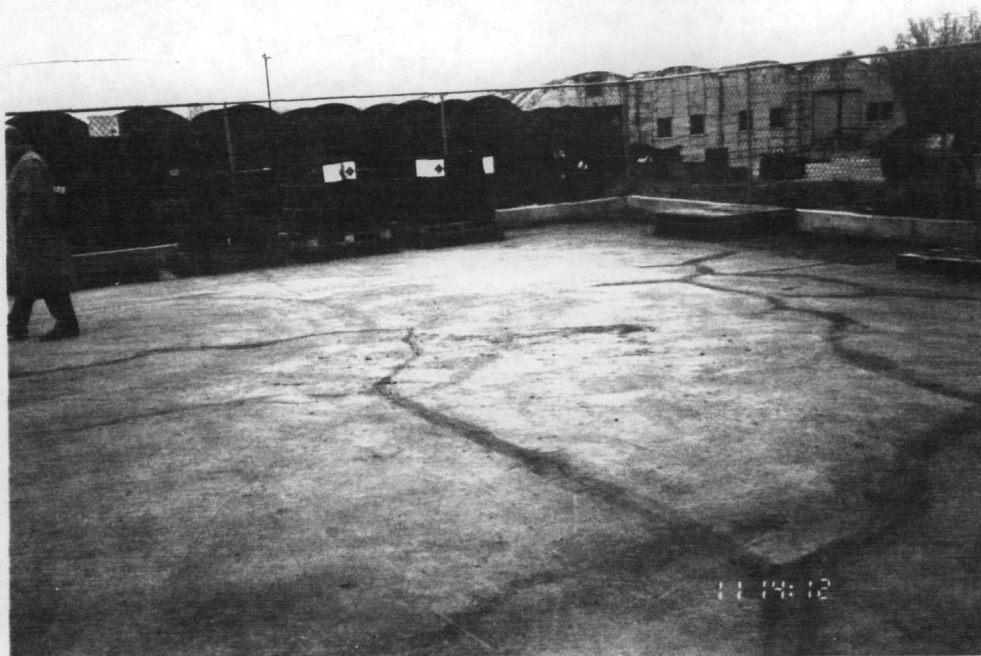
Photograph No. 7

Observations: The area contained approximately 50 55-gallon drums and two large batteries. No evidence of release was noted (See Photograph No. 7).

Description: Quonset hut-type building (upper right hand corner of photo) used for storage of empty waste drums and batteries.

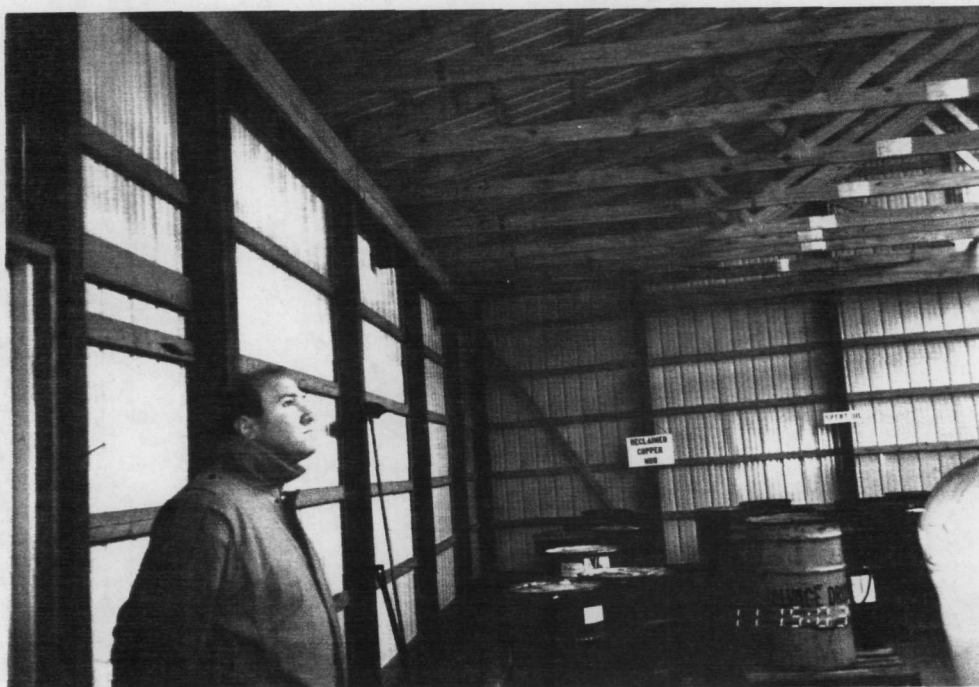
Photograph No. 17

Unit Description: The unit is located in a separate building on the south side of the main plant, between the railroad siding and the fence. The waste is stored in 55-gallon drums on skids, which rest on a concrete floor (see Photograph No. 17).
